BATTERY-MAX LITEIN Service Manual

LITEIN 30.0/ 37.5/ 45.0/ 52.5/ 60.0/ 67.5/ 75.0/ 82.5

Version 1.0

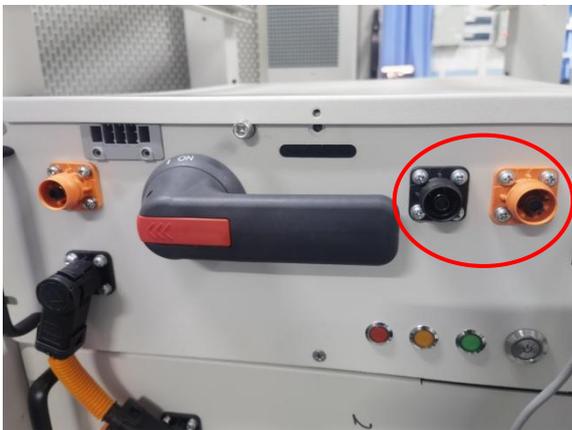
Disconnect the PDU and measure the tower voltage between the P+ and P- for PDU.

B+ and B- of tower voltage

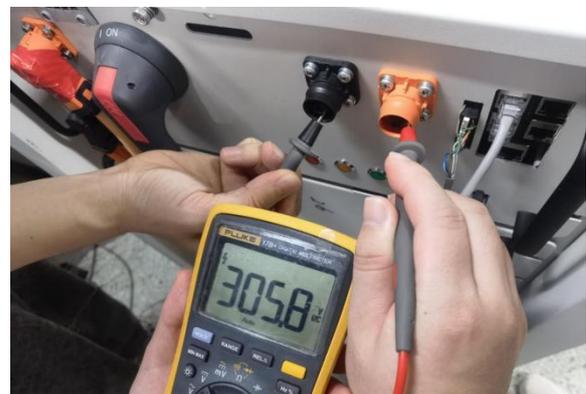
Measurement of tower voltage

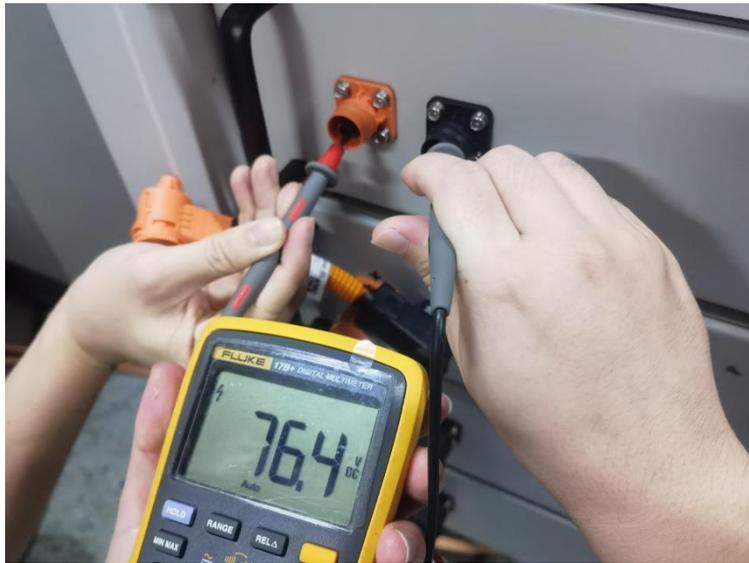
Note: The nominal voltage for per module is 64.8V~88.8V

Individual module measurement

If the measured voltage of the tower deviates from the nominal value, please check the voltage of the individual modules
